# GREENING Infrastructure

Concept designs for three sites in Hampden, MA  
By Nate Card & Lion Waxman

# EAST BROOK for a Living Watershed

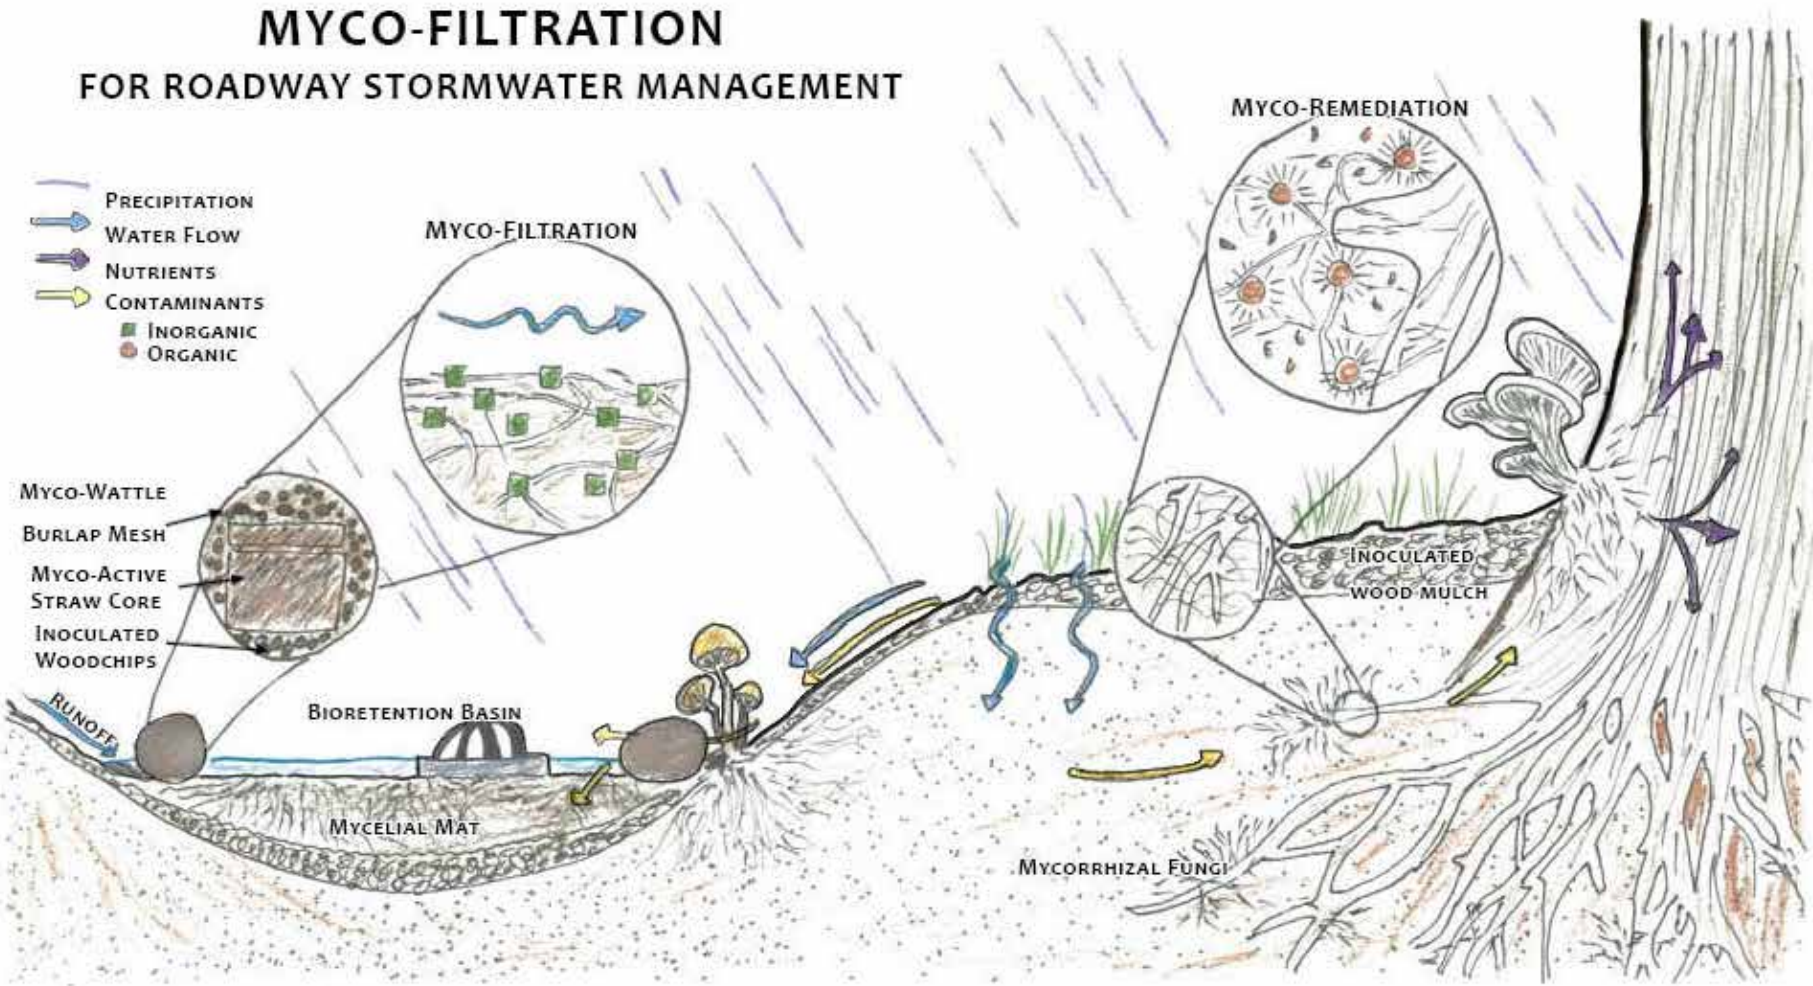
*Myco Wattles:* A burlap wrapped wattle is inoculated with saprophytic fungi and staked in place in the path of the flow of water along a contour similar to compost filter tubes and other erosion control measures, or in a bioswale along the edge of a check dam.

*Mycofiltration Bioretention Basin:* Enhancing the performance of standard bioretention basins, soils, compost or mulch can be inoculated with mycorrhizal or saprophytic fungi and applied to the basin.
